Manhole Inspection Summary

Manhole # S35KK_042MH

Insp Date: **3/12/07 7:02 AM**

Location Address: **124 TRENTON ST**

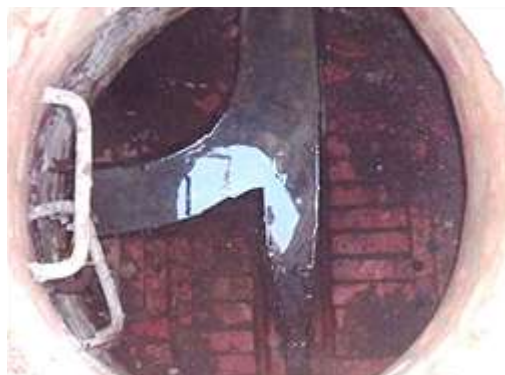
Top View

Corroded steps. Evidence of surcharge - Bench debris. Channel debris.

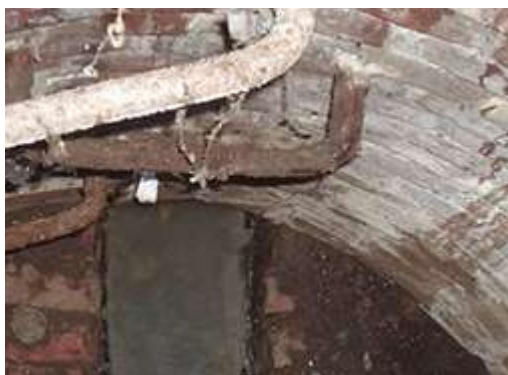
Defect

☒ **Evidence Of Surcharge**

Depth: **3**

Evidence of surcharge.

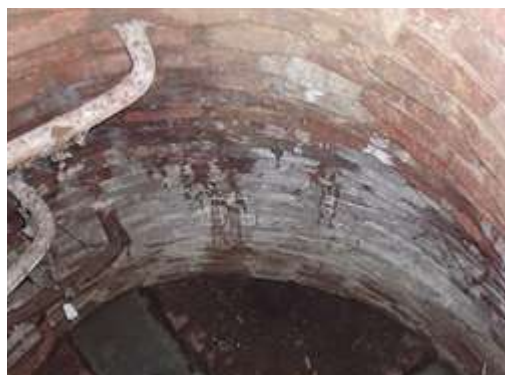
Defect

Infiltration: ☐ None ☐ Joint ☐ Cracks ☒ **Mortar** ☐ Roots ☒ **Wall**

Barrel infiltration.

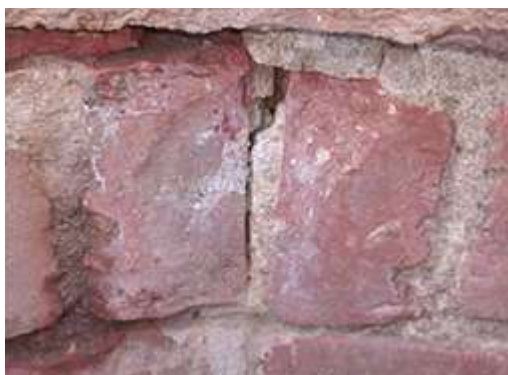
Defect

Condition: ☐ Sound ☐ Cracked ☐ Root Intrusion ☐ Loose Brick ☒ **Deteriorated**

Infiltration: ☐ None ☒ **Joint** ☐ Cracks ☒ **Mortar** ☐ Roots ☐ Wall

Adjustment deterioration and infiltration.

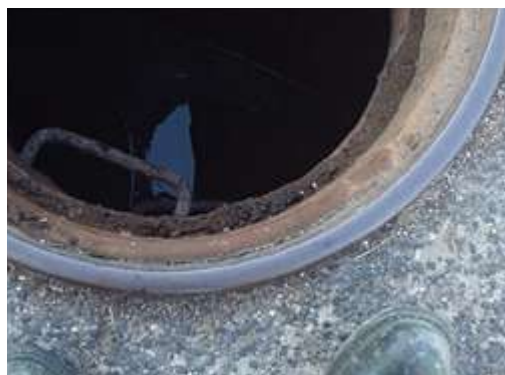
Defect

Offset: **1** (in.)

☒ **Leaks**

Frame leaks. Frame offset. Adjustment infiltration.

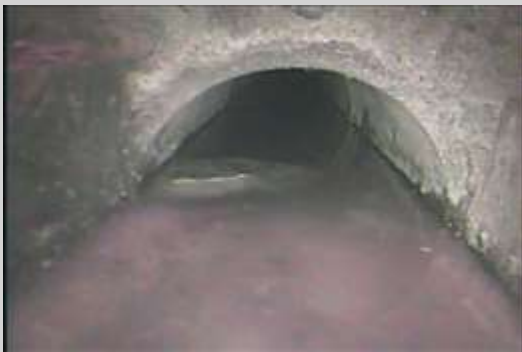
8 in. Circular Gravity Sewer Pipe Out @ 12 O'Clock

Deposits: ☐ None ☒ **Mud** ☐ Sludge ☒ **Debris** ☐ Grease

Silt Depth: **2** (in.) Deposits Extent: **Light**

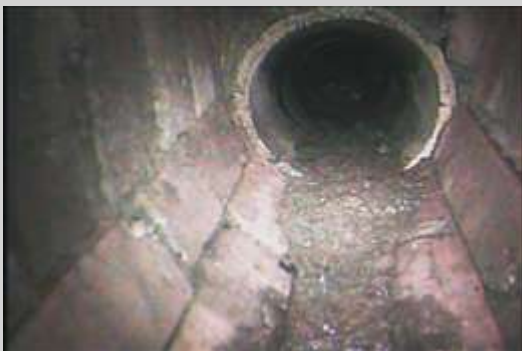
8 in. Circular Gravity Sewer Pipe In @ 6 O'Clock

Condition: ☐ Sound ☐ Cracked ☐ Root Intrusion ☒ **Deteriorated** ☐ Leaks ☐ Debris

Channel deterioration.

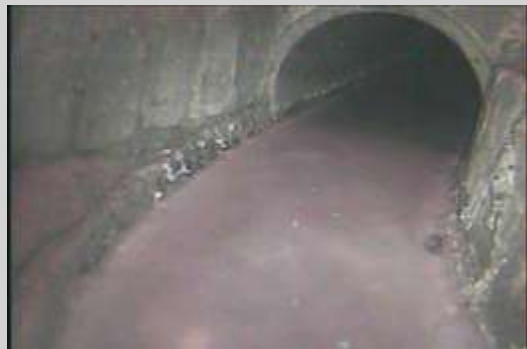
8 in. Circular Gravity Sewer

Deposits: ☐ None ☐ Mud ☐ Sludge ☐ Debris ☒ **Grease**
